**BUNNELL
LAMMONS
ENGINEERING**

July 19, 2021

Subject: **Revised Seep Mitigation Plan**
Greenpointe Class 2 Landfill
500 Hamlin Road
Easley, Anderson County, South Carolina
Permit No. LF2-00001
BLE Project Number J21-11728-14

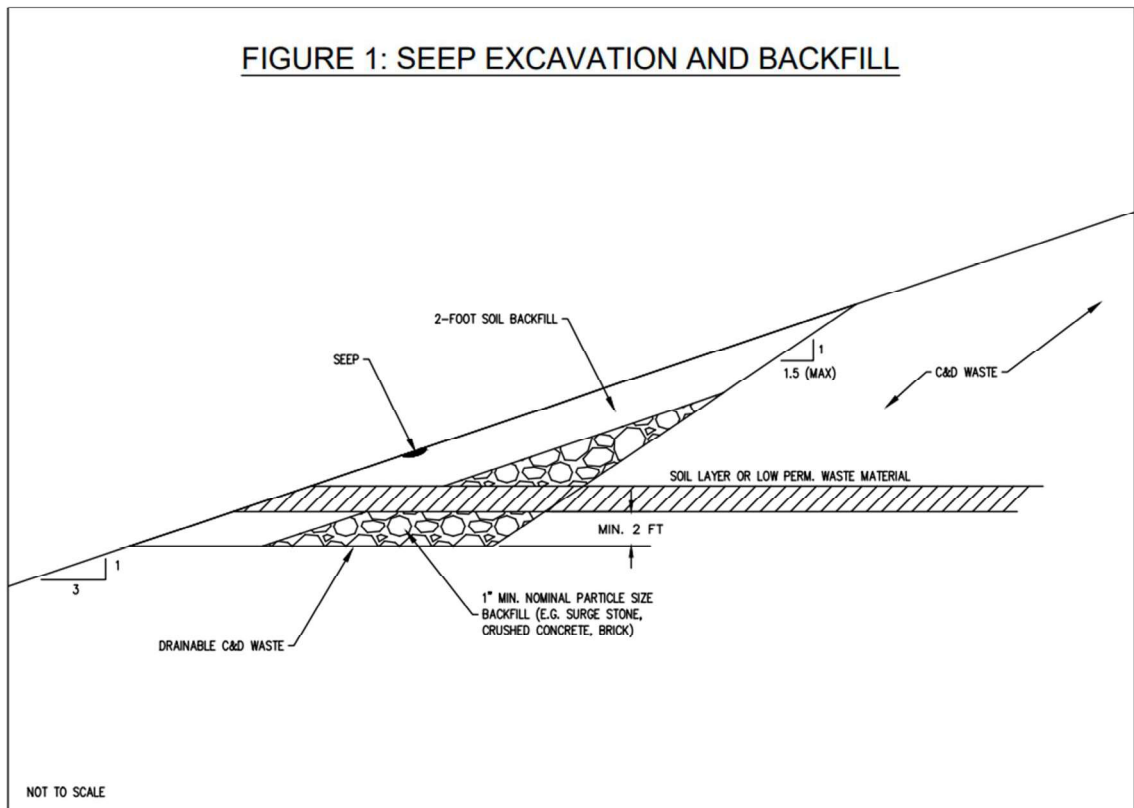
Liquid seeps are typically experienced at a vertical discontinuity in waste mounds, which can be due to a layer of lower permeability waste or a layer of intermediate cover soil. Seeps located above the toe of waste are more likely to be perched on a layer of intermediate cover soil. On-site soil generally consists of red-brown elastic silt, sandy silt and silty sand which generally have a lower permeability than C&D wastes. Intermediate waste slope grading plans are being prepared by others to improve storm water runoff which should result in less infiltration over the landfill topdeck and thereby less liquid to create seeps. The following plan provides a process of locating, controlling and mitigating seeps.

2. When encountered, the seeps should be excavated up and down the slope beginning 1-3 feet below the lowermost seepage point, forming a trough above and behind the seep to penetrate lower permeability waste or cover soil which could be creating the lower permeability zone. The excavation should extend a minimum of 2 feet below the apparent lower permeability zone and should cover the entire ground surface where seepage was observed, plus 2 feet in each direction. Figure 1 below presents an excavation and backfill schematic to be used as a guide to excavation and backfilling.

*****Excavations made at 1.5H:1V slope should not be more than 8 feet deep. Excavations up to 12 feet deep may be made at a 2H:1V slope or flatter.*****

3. The excavation is to be filled with durable, mineral-based backfill with a minimum nominal particle size of 1-inch, i.e. minimum D₅₀ of 1 inch. Examples of suitable backfill include, but are not limited to: quarry aggregate such as railroad ballast, crushed concrete, and crushed masonry.
4. The final 2 feet of backfill should consist of compacted, on-site clayey or silty soil placed in 12-inch thick lifts.
5. The area should be re-observed no later than three (3) days after completing the repair for reoccurrence of seepage. Should seepage reappear, offset excavations should be performed on each side of the initial repair but between 5 and 10 feet from the prior location. Figure 2 below presents a schematic of an offset repair.
