# CSXT Bramlett Road MGP Site Update

Lucas Berresford, Manager State Voluntary Cleanup Program

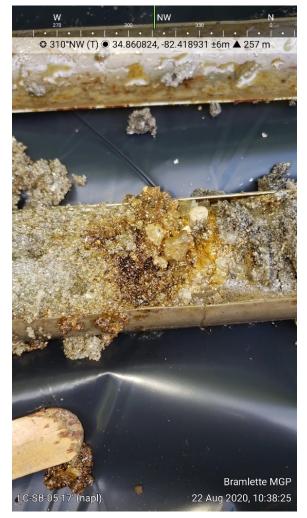
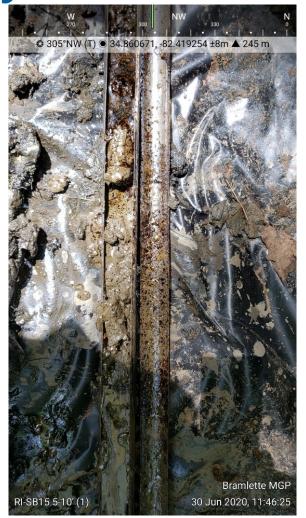
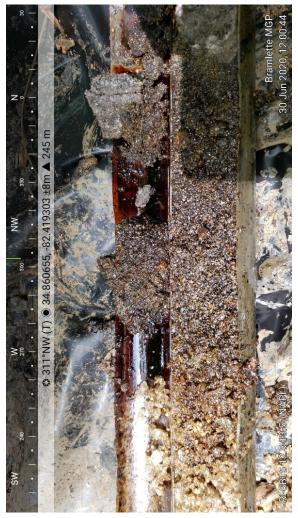
### **Visually Observed Coal Tar**

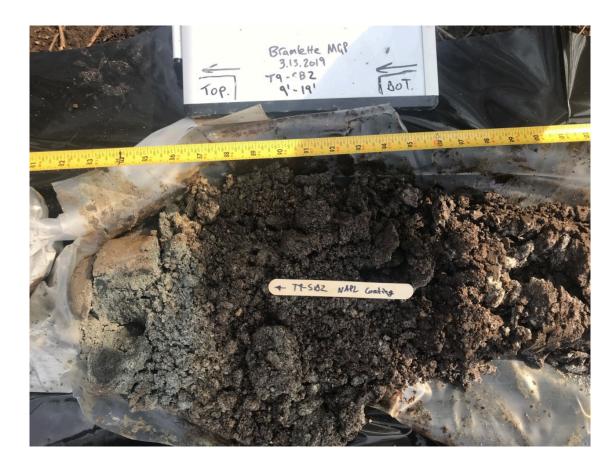
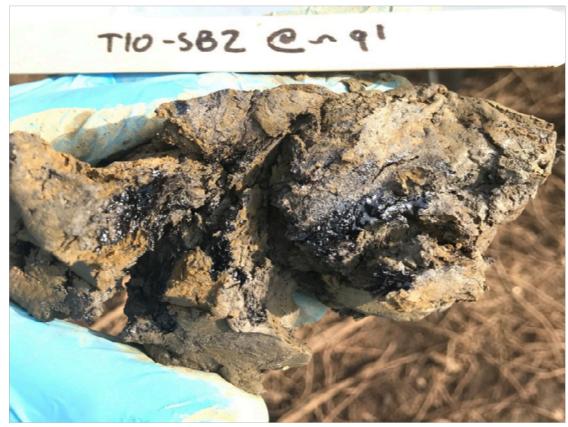
### **Visually Observed Coal Tar**

Oil-Like Material

Tar-Like Material

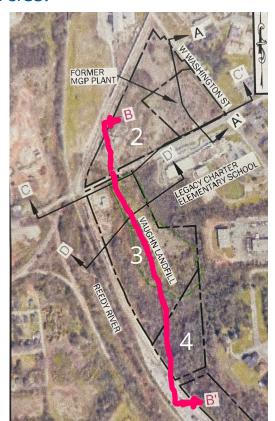
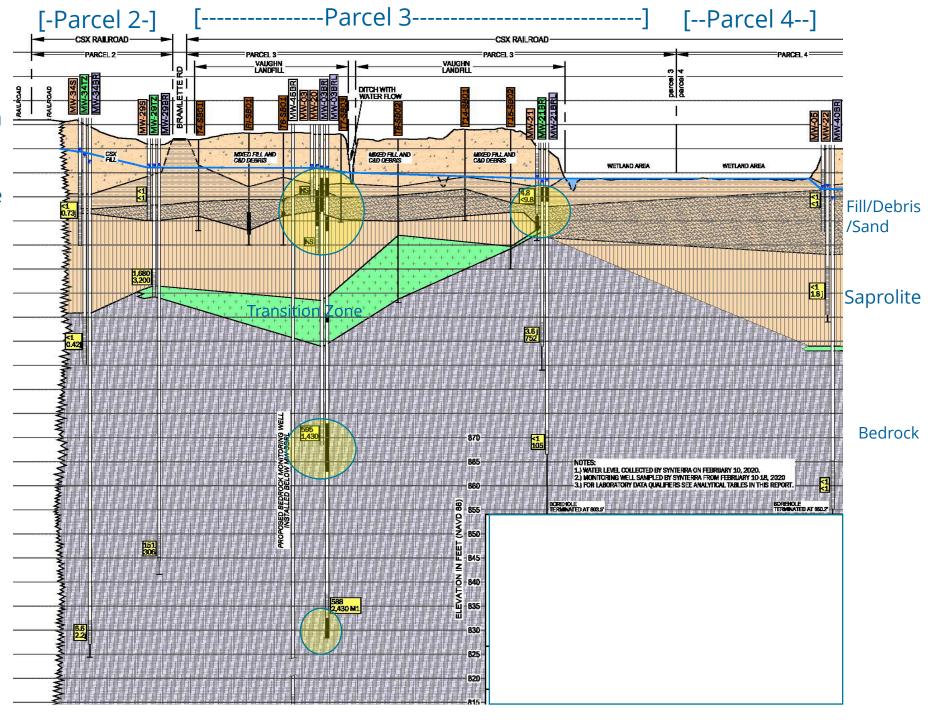
#### **Cross-Section**

Figure shows a cross-section from B to B' across Landfill Area

Coal Tar is identified by the black bars within the wells. The wells with observable coal tar are highlighted with the yellow circles.

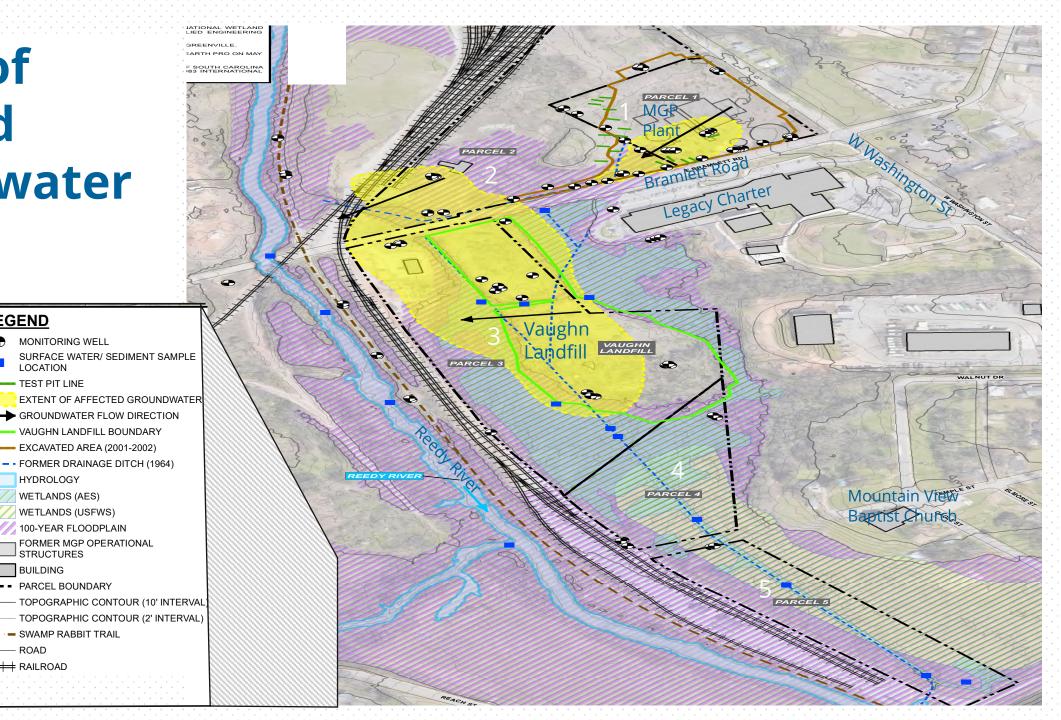
# **Extent of Affected** Groundwater

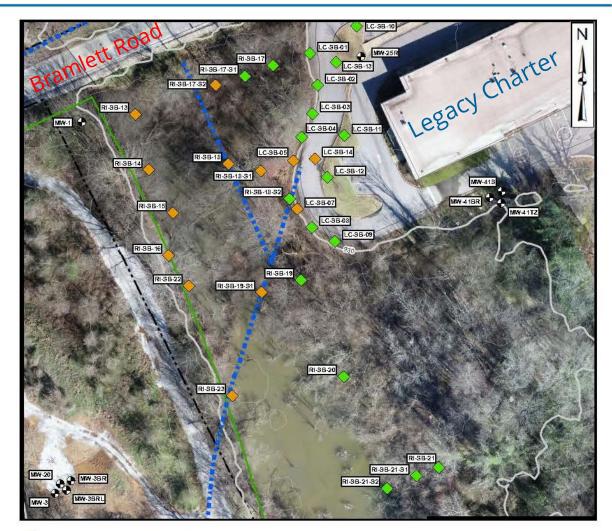
#### **Soil Boring Findings**

- Tar-like Material found beneath the school driveway at 14-19 feet bls limiting potential dermal contact
- Tar-like Material found 1 ft to 14 ft bls between Vaughn Landfill and the school driveway

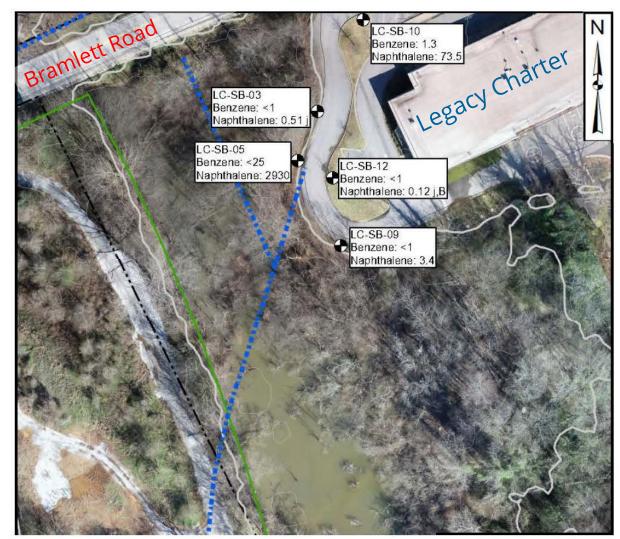
#### **Groundwater Quality**

- 5 Samples Collected from Shallow Temporary Monitoring Wells
- Naphthalene and Benzene detected above Maximum Contaminant Levels near the historical ditch

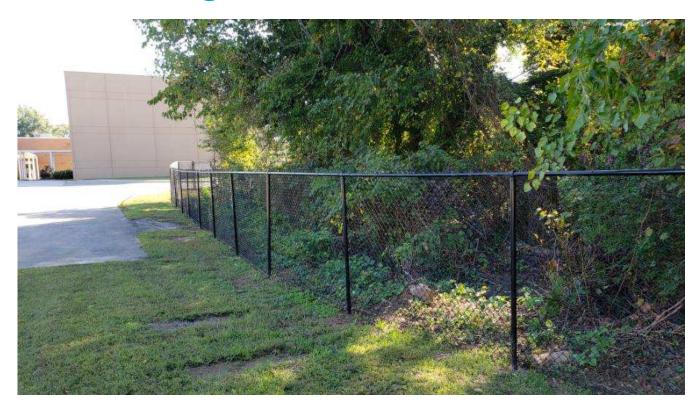
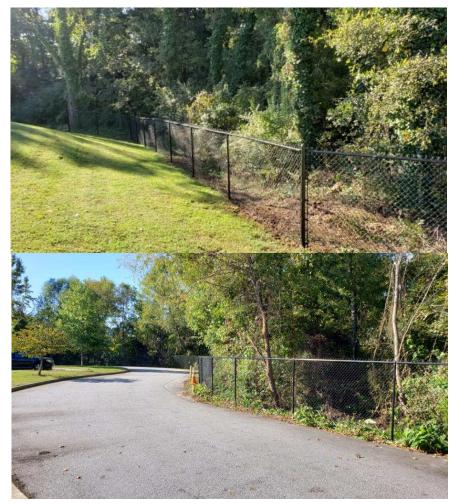
# **Legacy Charter Wetlands Barrier**

• Duke has added 720 linear feet of fencing to limit access to this area

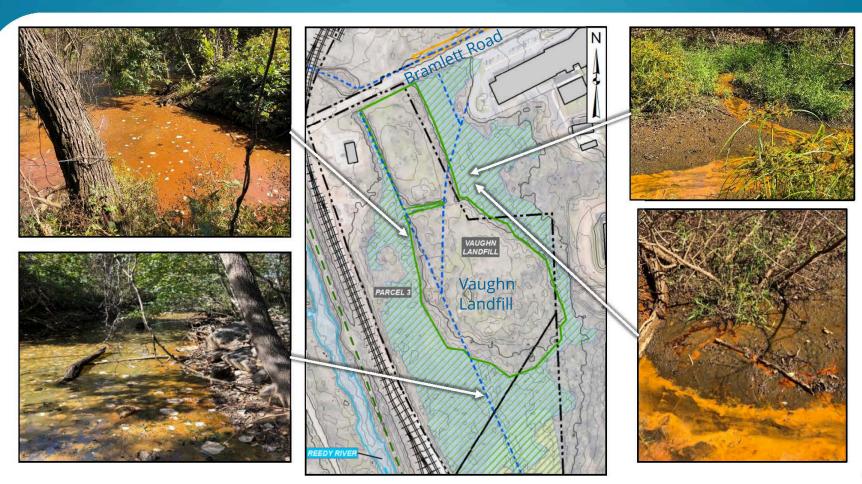
#### October 2020 Site Observations

- Assess the Former Stormwater Conveyance Ditches
- Collect sediment and soil samples from at least 55 locations along the conveyance ditches
- Define the extent of coal tar in ditches
- Evaluate volatile organic compounds (VOCs) and semi-volatile organic compounds (SVOCs) in ditches

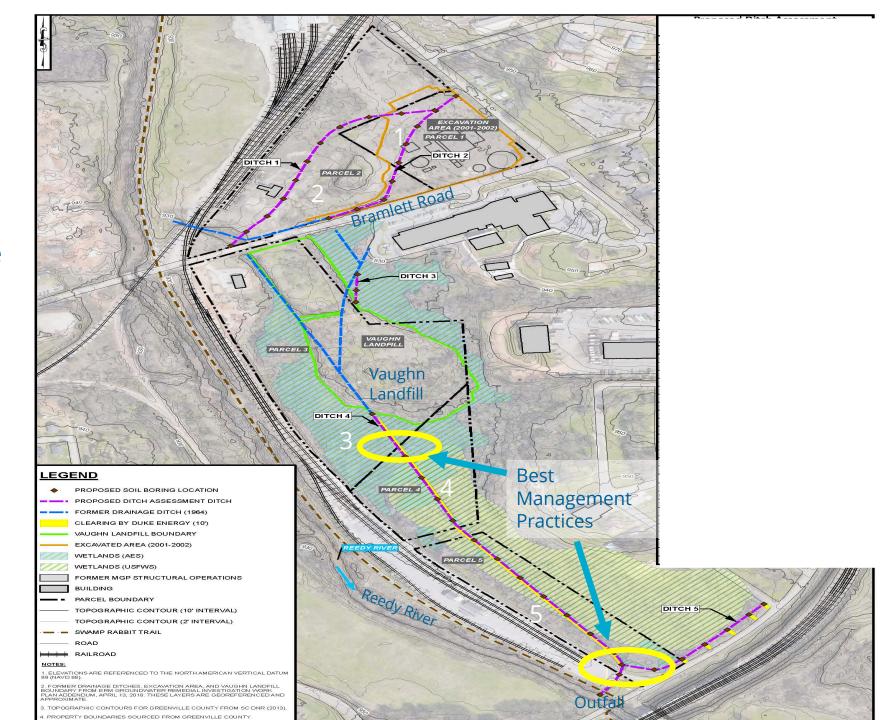
- Preliminary Findings indicate that Sediment Samples have some Coal Tar At or Near the Surface in the Historical Drainage Ditches
- Duke Energy has
   Proposed to Utilize a couple of Best
   Management Practices to limit any movement of Sediment within the Historical Drainage
   Ditches
- Currently Evaluating the following Two Areas Circled in Yellow
