Total Maximum Daily Load Document  
Turkey Creek and Tributaries  
Stations: RS-08068 and SV-352  
(Hydrologic Unit Codes: 030601070201, 030601070202, 030601070203,  
030601070204, 030601070205, 030601070206, 030601070207, 030601070208,)  
*Escherichia coli* Bacteria,  
Indicator for Pathogens

April 2017

Technical Document Number 0406-17

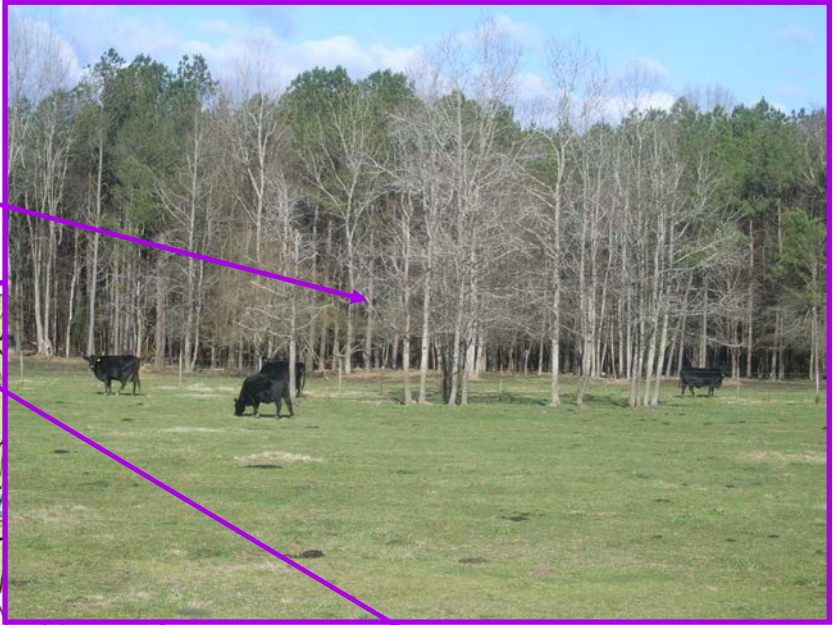
**Figure F-9**

Pastured cattle near Stevens Creek (location: 33.95420 N, -81.90262 W) on US 378 in Edgefield County. Found in Reach 1 of the TCT Watershed (Date of photography: February 25, 2016).

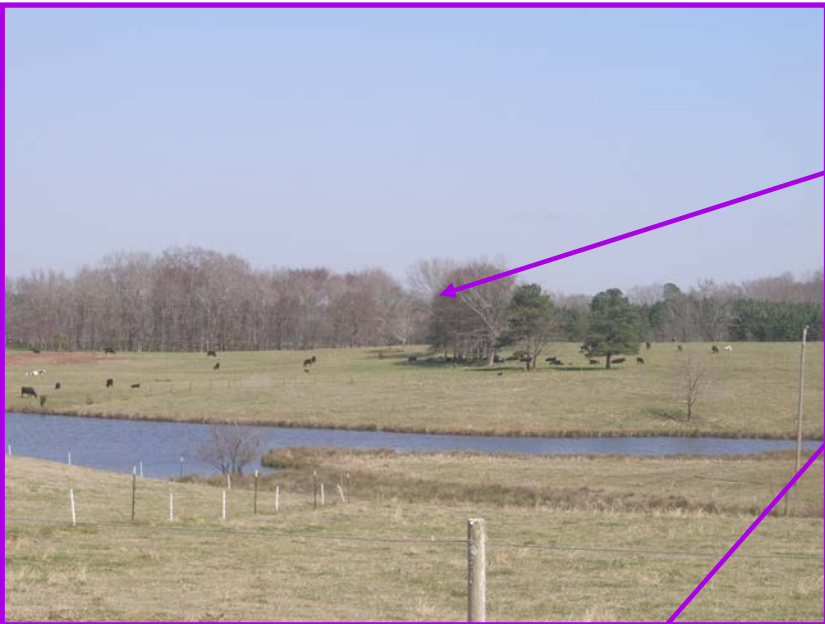
**Figure F-10**

Cattle in pasture with a stream-fed pond (location: 33.80398 N, -81.89971 W) on SC 430 in Edgefield County. Found in Reach 1 of the TCT Watershed (Date of photography: February 29, 2016).

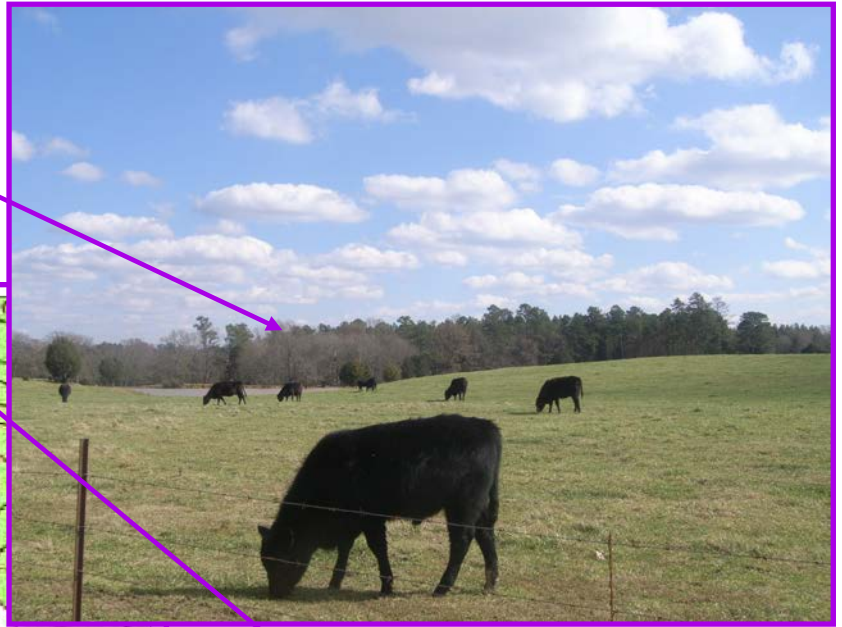
**Figure F-11**

Cattle in pasture near a pond (location: 33.89939 N, -82.02643 W) on Timmerman Road in Edgefield County. Found in Reach 1 of the TCT Watershed (Date of photography: February 25, 2016).

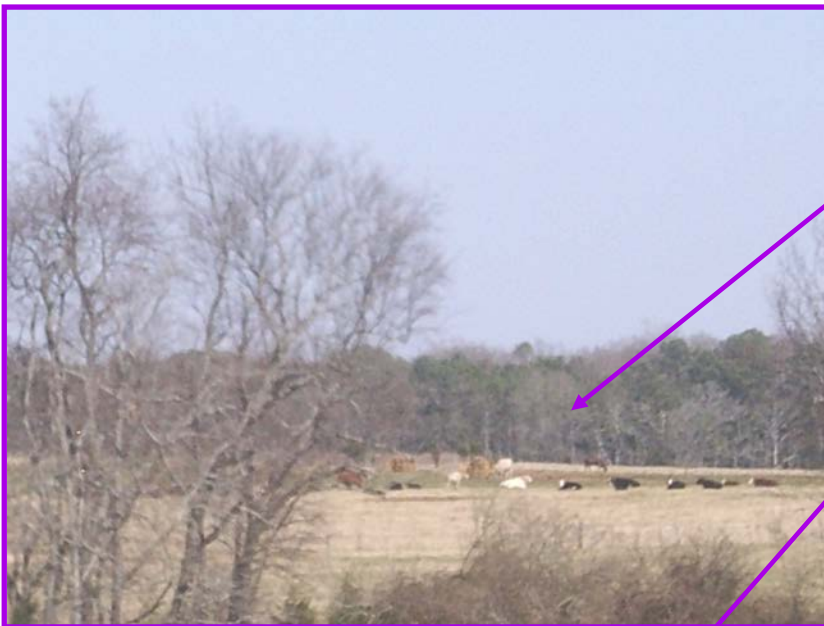
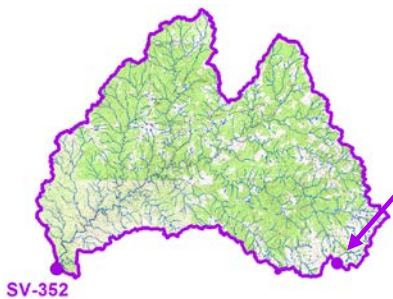
**Figure F-12**

Cattle in pasture with a stream-fed pond (location: 33.80176 N, -81.84275 W) on Bouknight Road in Edgefield County. Found in Reach 1 of the TCT Watershed (Date of photography: February 29, 2016).

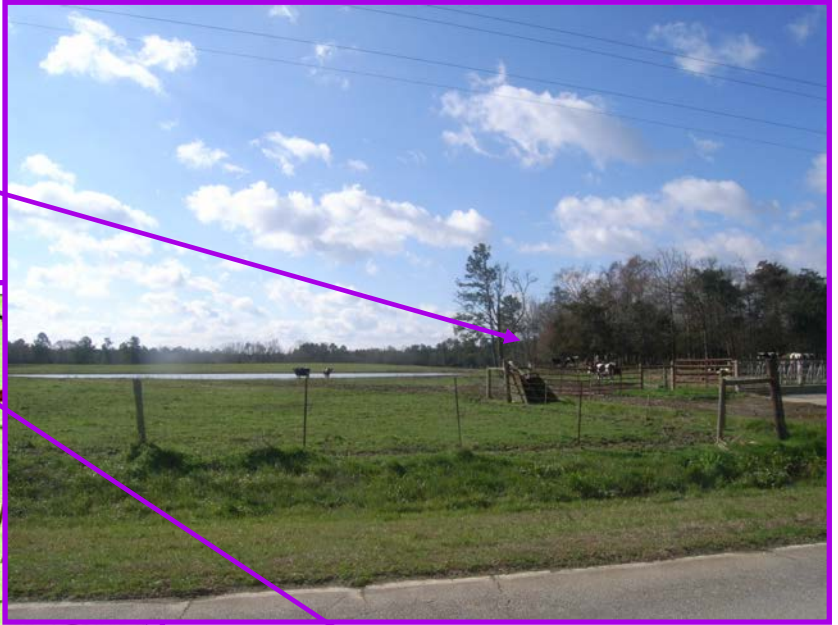
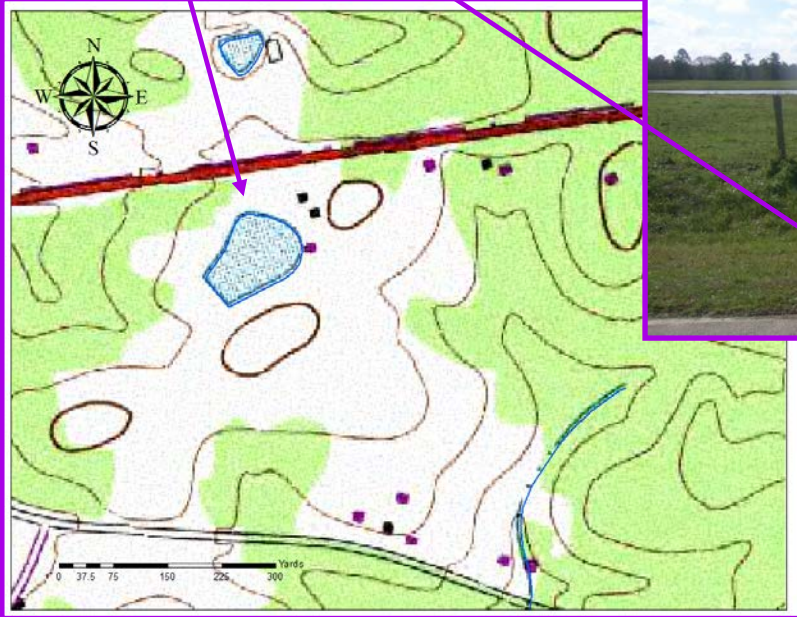
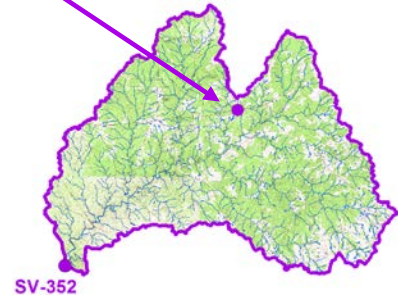
**Figure F-13**

Cattle in pasture near a pond (location: 33.93574 N, -81.96027 W) on US 378 in Edgefield County. Found in Reach 1 of the TCT Watershed (Date of photography: February 25, 2016).
