INVISTA Spartanburg Site Assessment Report June 2010

Table 1
June 2010 Sampling Plan
INVISTA Spartanburg Facility
AECOM Project No. 60135440

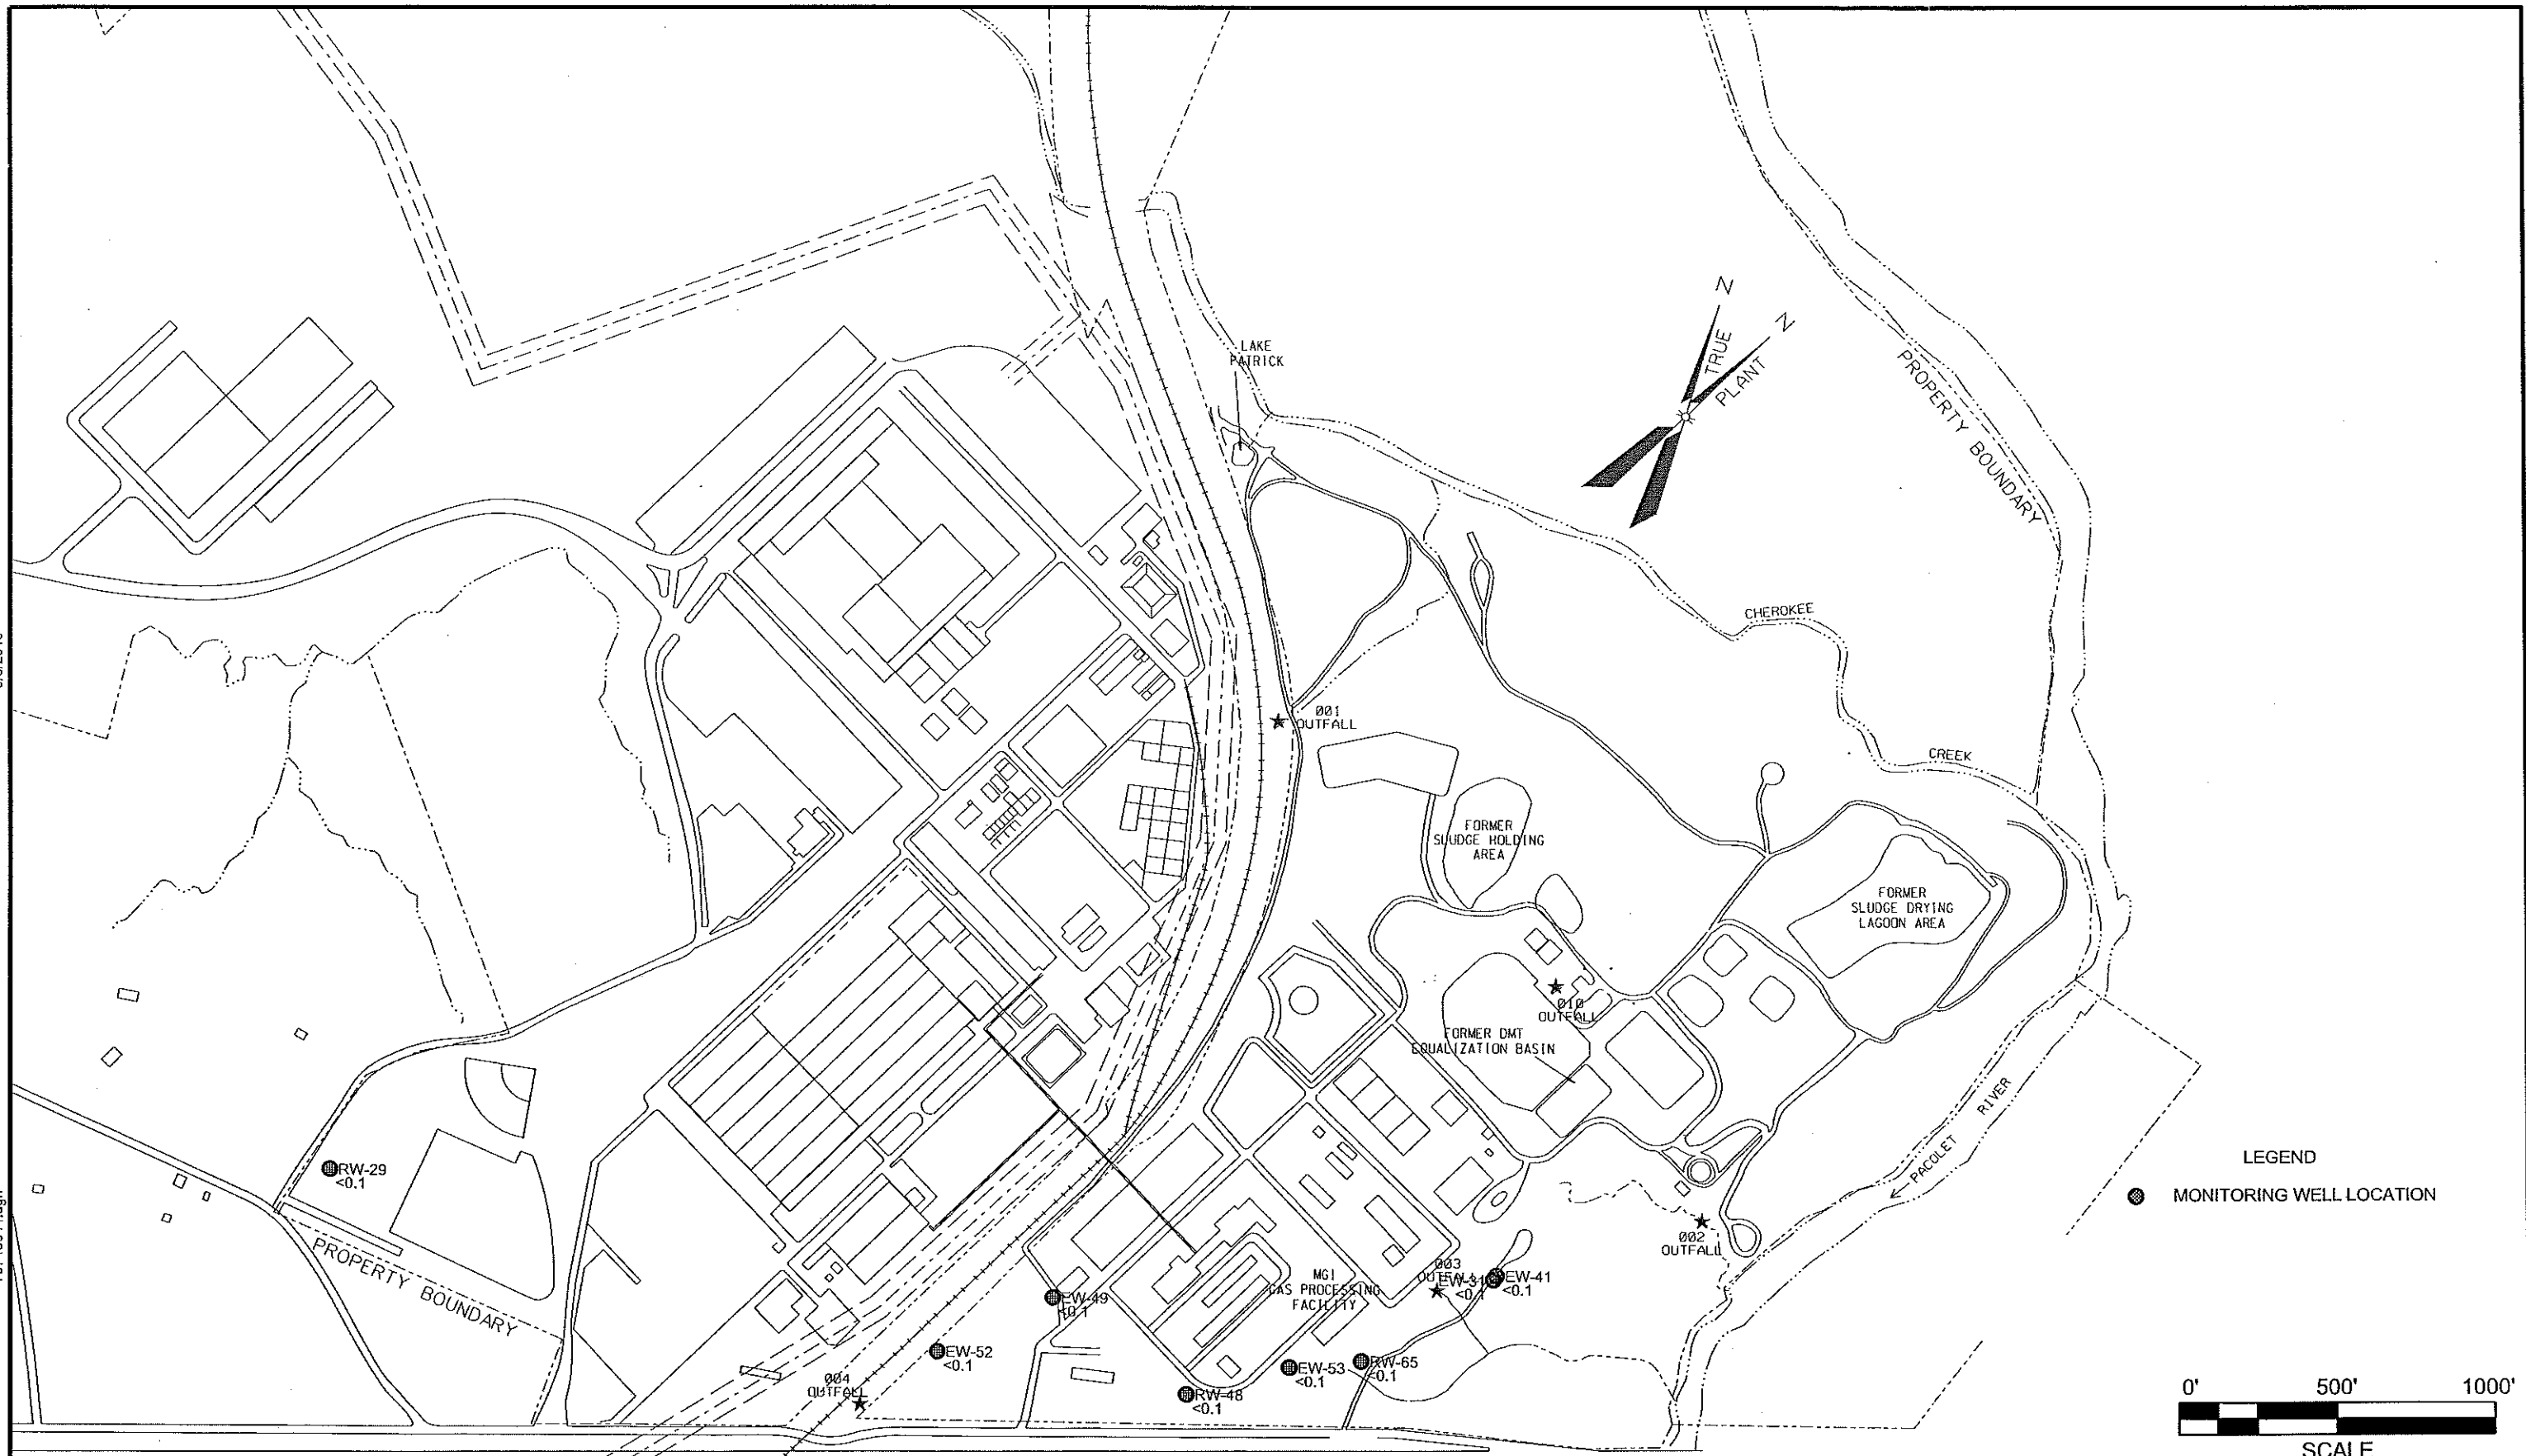
FIGURE 27
BEDROCK NITRITE
CONCENTRATIONS
 CNA HOLDINGS, INC.
 SPARTANBURG, SOUTH CAROLINA

Nitrate and Nitrite results are presented in Figures 24 through 27. These parameters are only monitored in the former DMT area. Nitrate is converted to nitrite under reducing conditions. Detections of nitrate were noted primarily in saprolite in the same region with chloroform detections. There were no detections of nitrite. Because the detections of nitrate correspond to the area of chloroform detections, it is likely that nitrate was present at other locations but has been reduced and nitrite is either precipitated or further reduced through denitrification.
